NATIONAL TRANSPORTATION SAFETY BOARD

MATERIALS LABORATORY FACTUAL REPORT

Report No. 22-022

Place : Briggs, Texas
Date : July 30, 2021
Vehicle : HpH, Spol. S.R.O. Glasflügel 304S, N304AB
NTSB No. : CEN21LA346
Investigator : Andrew Todd Fox, ASI – CEN

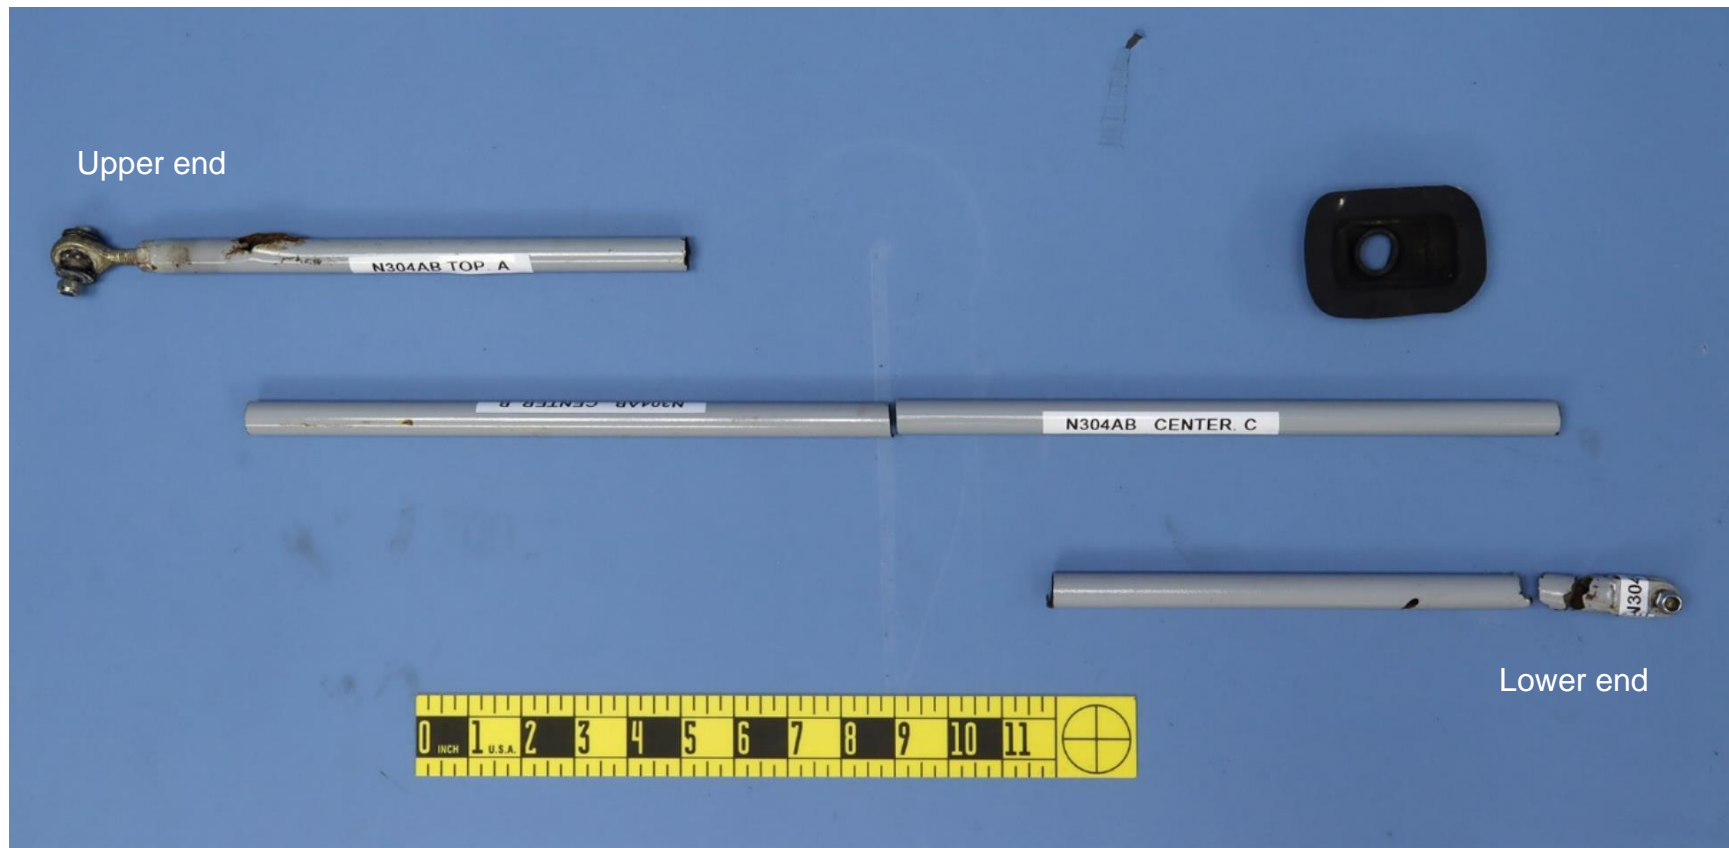
Pieces of an elevator control rod and a rubber sealing boot were submitted to the NTSB Materials Laboratory for examination as shown in figure 1. The control rod was sectioned at three locations prior to shipping and fractured in two locations at its lower end. By design, the rod sits inside the vertical stabilizer in a vertical orientation. The upper end is terminated by a rod end bearing and the lower end is terminated by a clevis fitting. The sealing boot is installed over the rod at its upper end.

Figure 1: Image of the elevator control rod pieces and rubber boot as received.

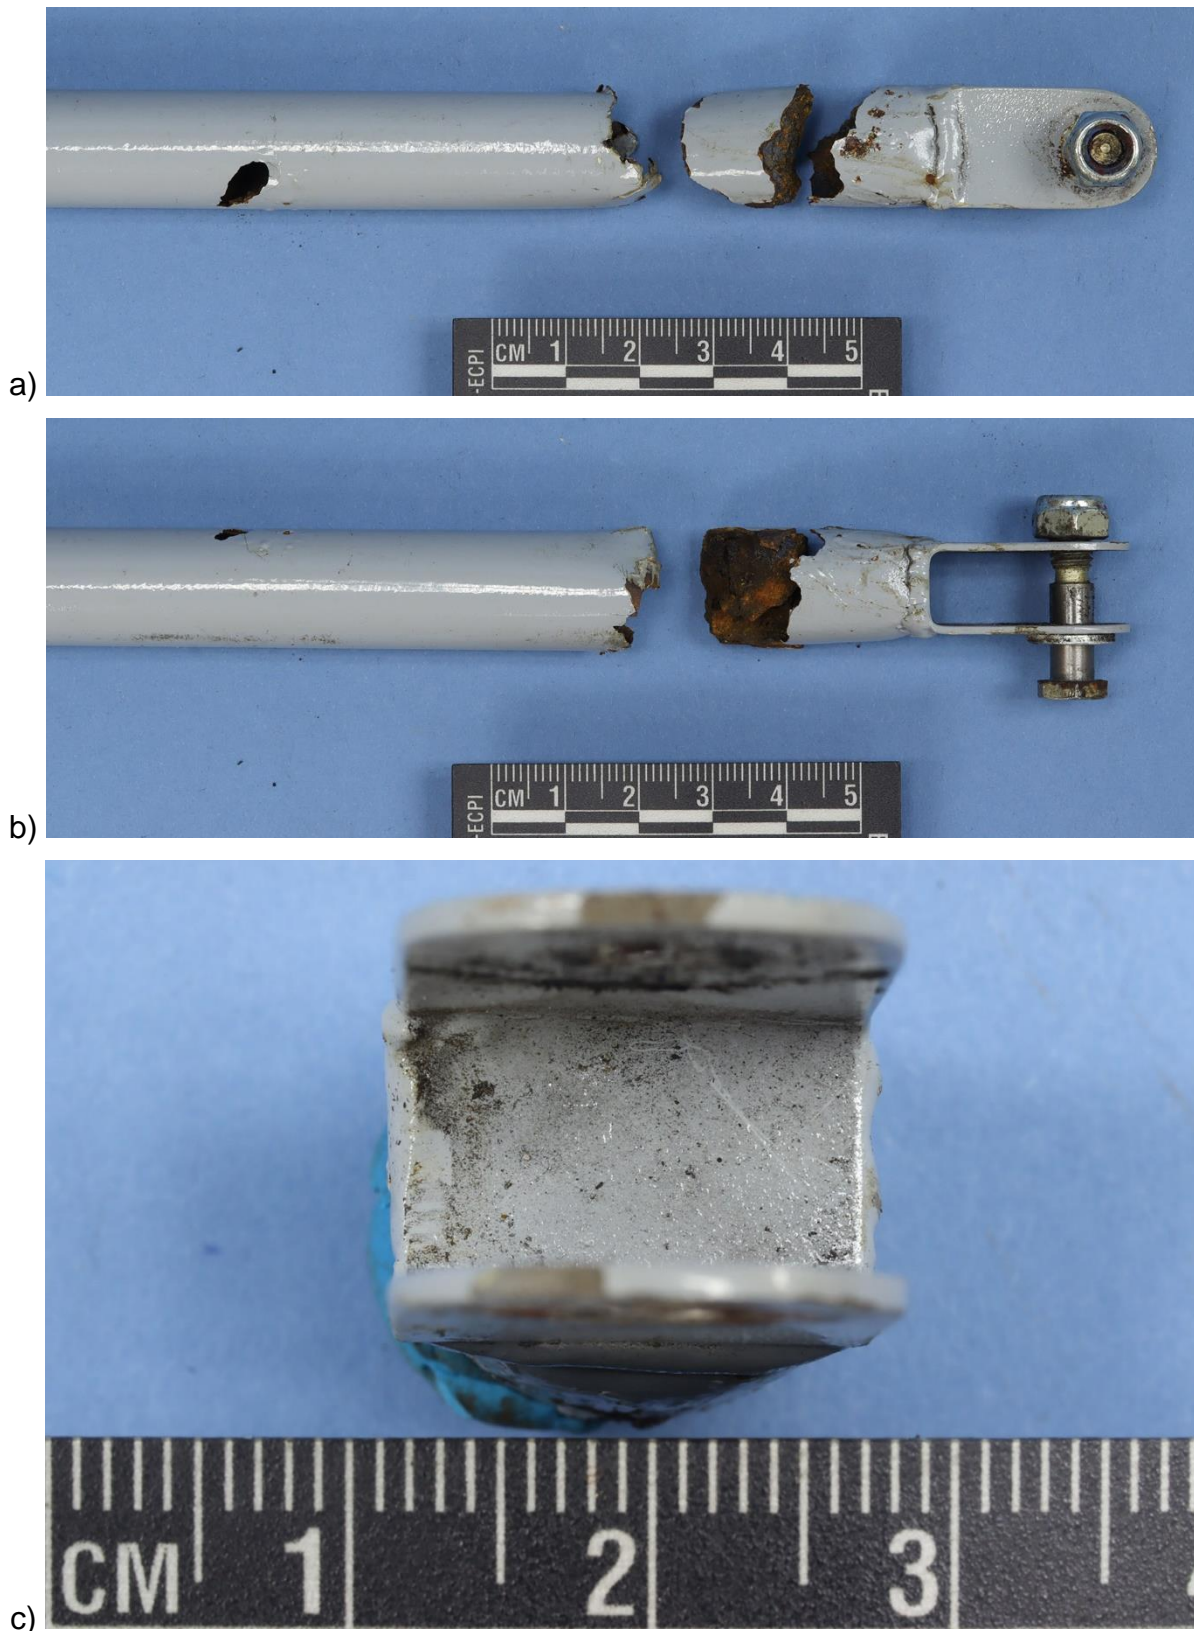
The control rod had fractured in the circumferential direction at two locations at the lower end adjacent to the clevis fitting, as shown in figures 2a and 2b. The fractures were coplanar with the upper and lower faces of a plug of corrosion product that had filled the majority of the inner cavity and measured between approximately 9 mm and 15 mm (between approximately 0.35 inch and 0.60 inch) in length. The fracture surfaces were examined and exhibited features consistent with overstress and loss of wall thickness due to corrosion. The clevis fitting at the lower end of the rod was examined for indications of a drain hole but no drain hole was observed, as shown in figure 2c.

Figure 2: The lower end of the control rod: a) and b) two views of the fractured end and c) image of the clevis end fitting shown no drain hole present.

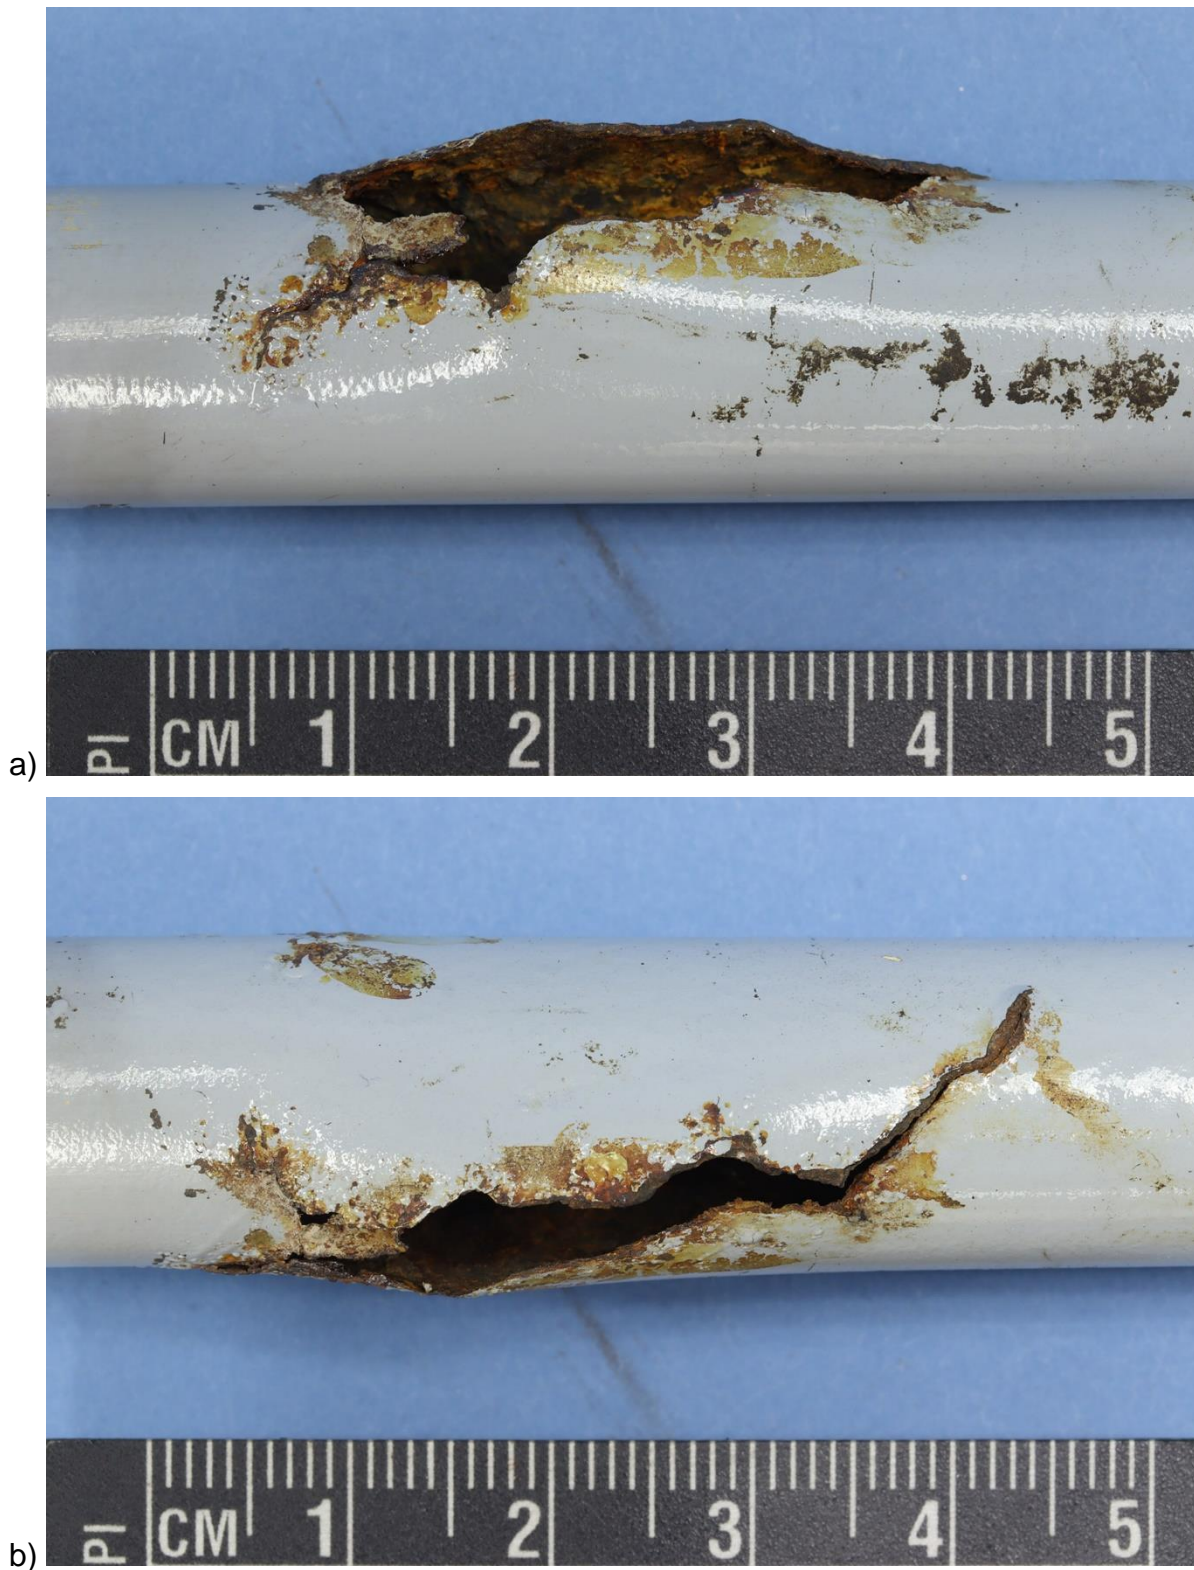
The control rod had also fracture in the longitudinal direction near the rod's upper end, as shown in figures 3a and 3b. The midpoint of the fracture was approximately 55 mm (2.2 inch) from the upper end of the rod and it extended approximately 40 mm (1.6 inch) in the longitudinal direction. The fracture surfaces were corroded as was the inner surface of the tube and the surrounding paint was bubbled and stained. The tube material bulged outward on either side of the fracture. The features were consistent with internal corrosion and an overstress fracture. The outside of the tube above the longitudinal fracture exhibited a dark stain over a length of approximately 22 mm

Figure 3: a) and b) Two views of the longitudinal fracture at the upper end of the control rod.

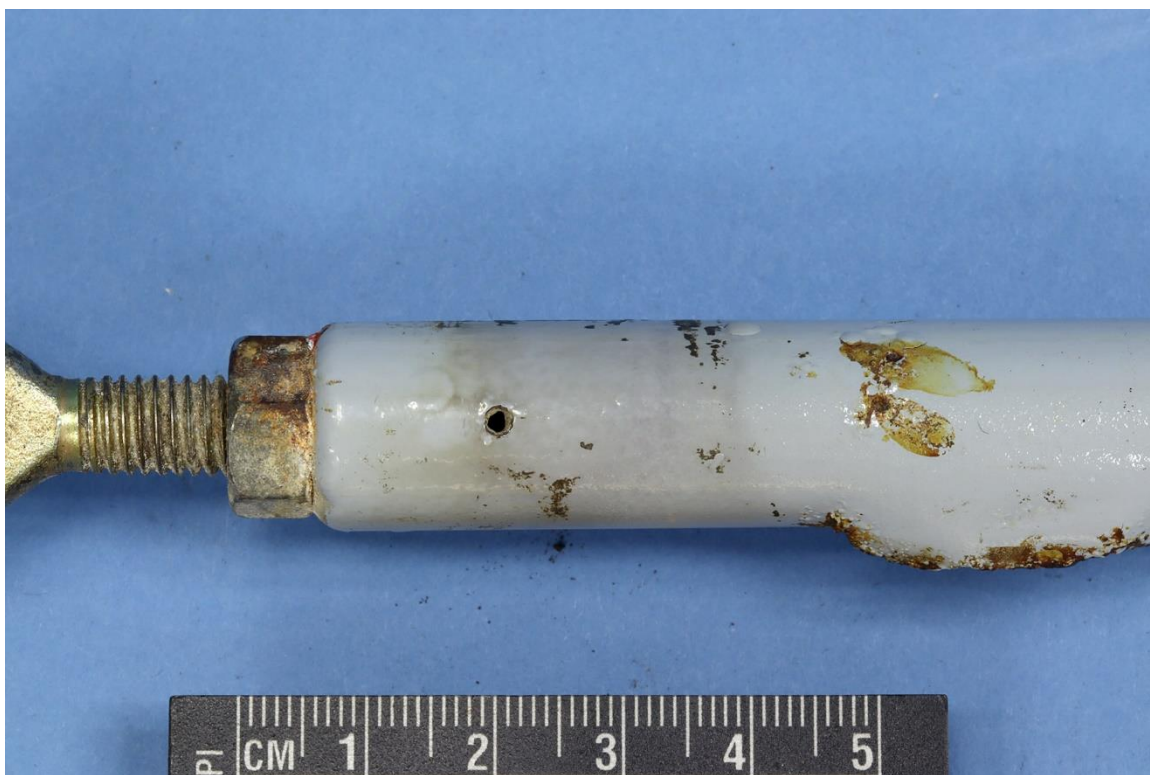
(0.87 inch), as shown in figure 3c, consistent with contact with the collar on the rubber boot. The stain extended just above the level of the witness hole.

c) **Figure 3 (cont.):** c) upper end of control tube showing staining from the rubber boot in the vicinity of the witness hole.

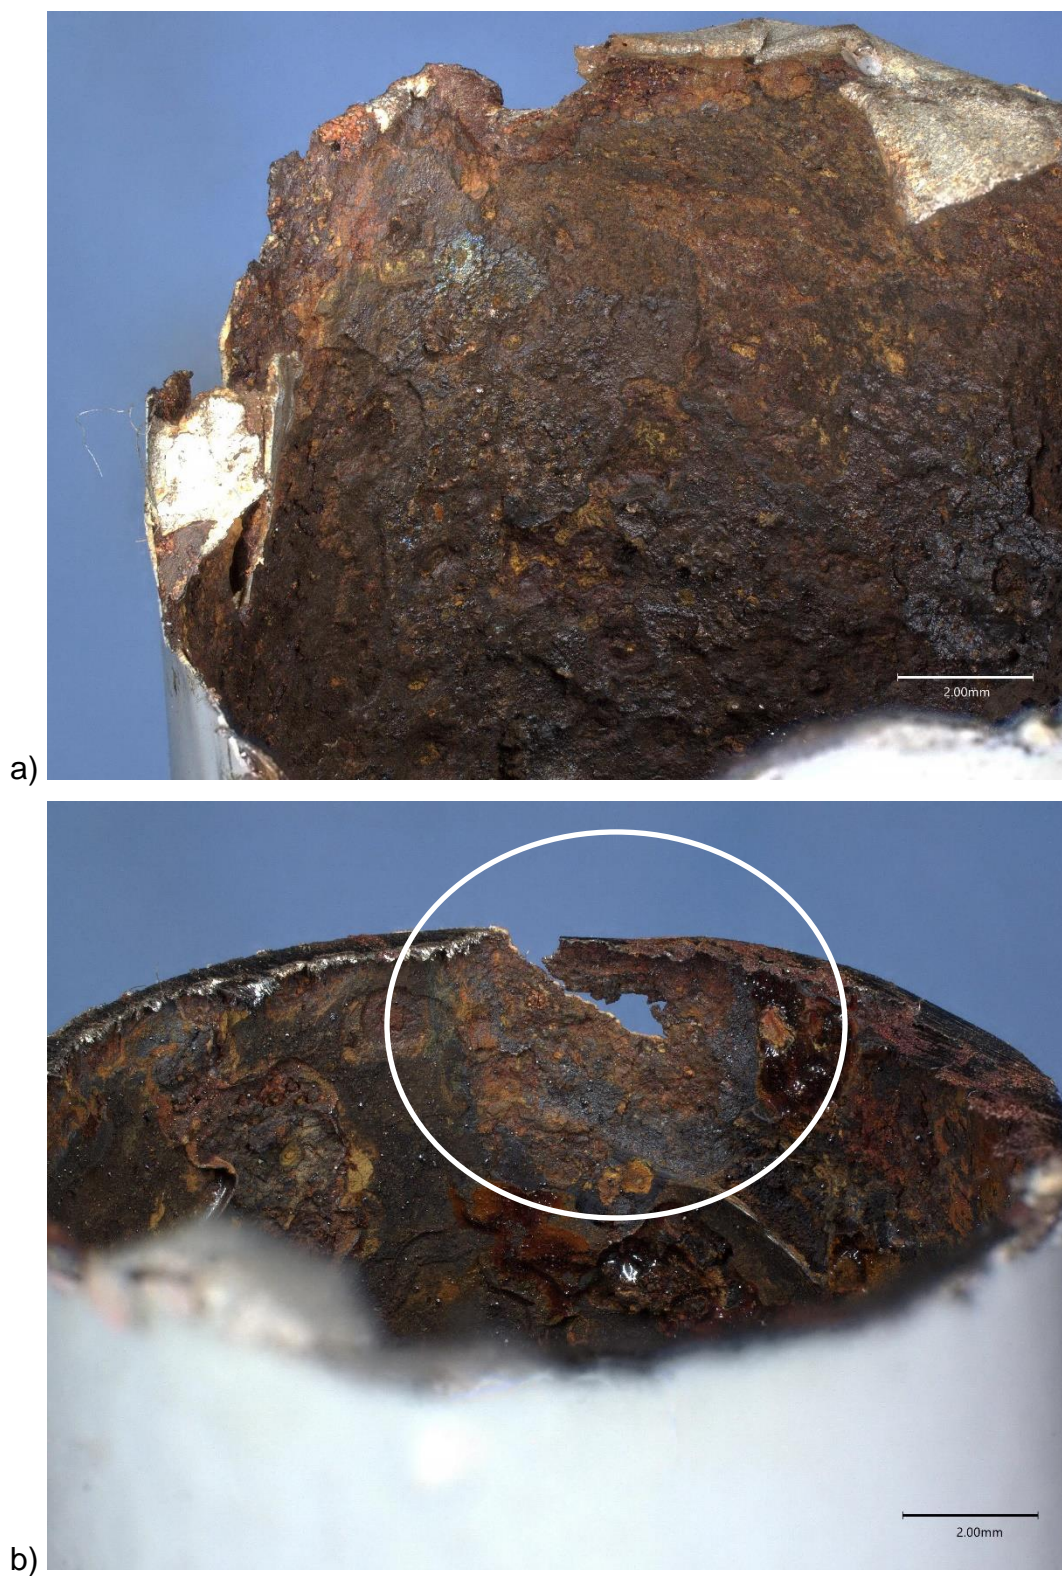
Internal corrosion was observed along the entire length of the rod, as shown in figures 4a and 4b. Figure 4a shows the inner tube surface at the lower end fracture where little wall thickness remained. Figure 4b shown the tube near its midpoint, where corrosion product was observed on the inner surface as well as spots where the corrosion had consumed the wall material.

Figure 4: Images of corrosion on the inner tube surface, a) near the fractured lower end and b) near the middle of the tube.
